Save Energy by Refurbishing and Coating Pumps

Monroe County Water Authority (N.Y.) discovered that coating pumps prevents or at least impedes a decline in pump performance and corresponding increase in energy consumption from internal corrosion and tuberculation buildup. **BY PAUL MAIER, CHRIS KING, AND RICHARD METZGER**

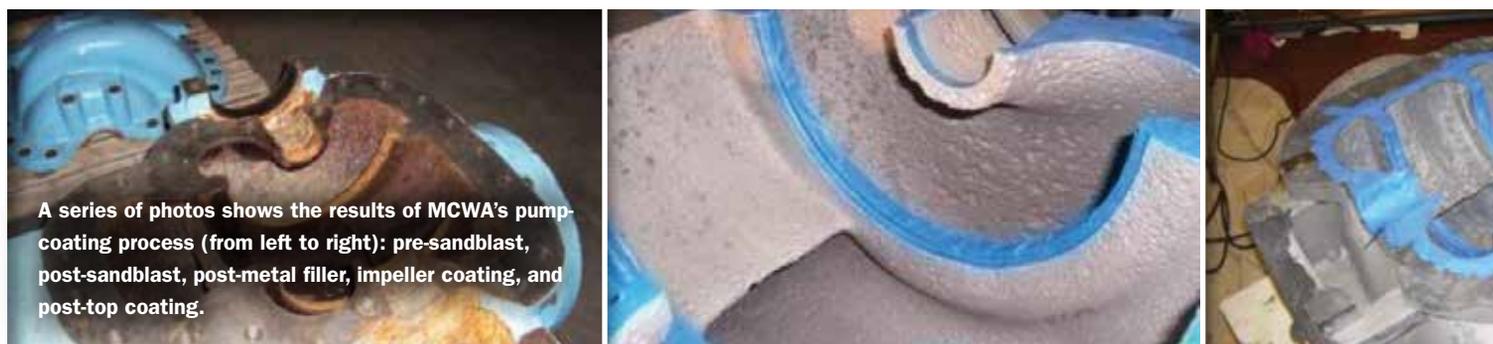
A series of photos shows the results of MCWA's pump-coating process (from left to right): pre-sandblast, post-sandblast, post-metal filler, impeller coating, and post-top coating.

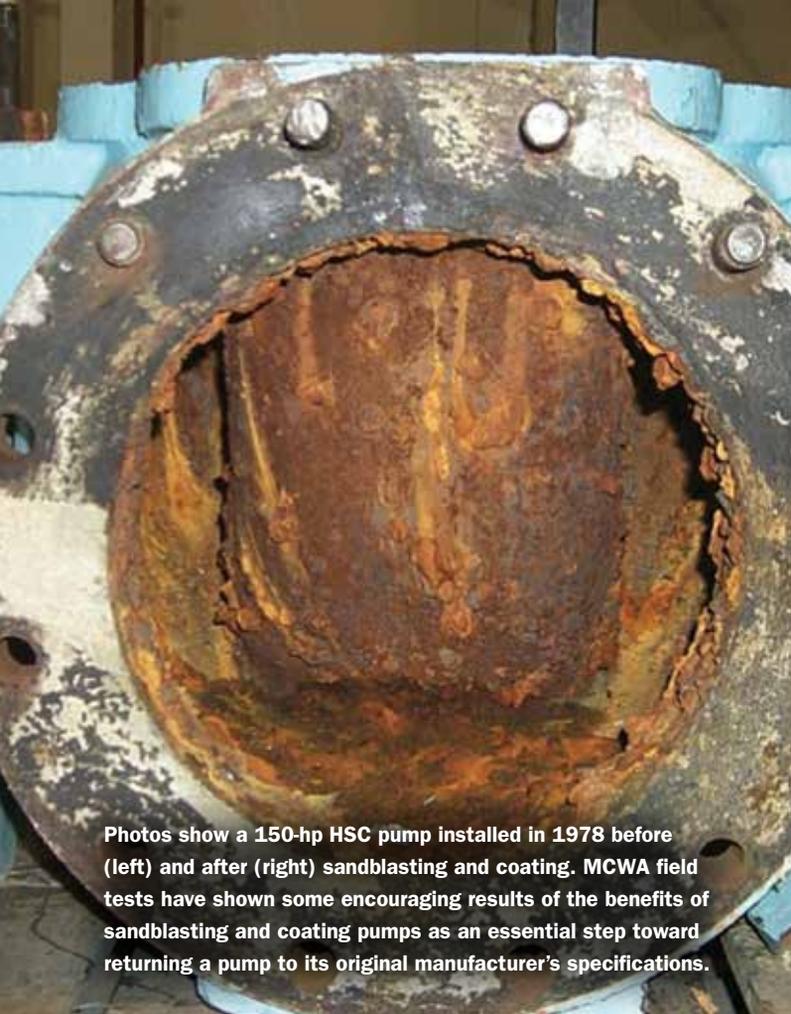
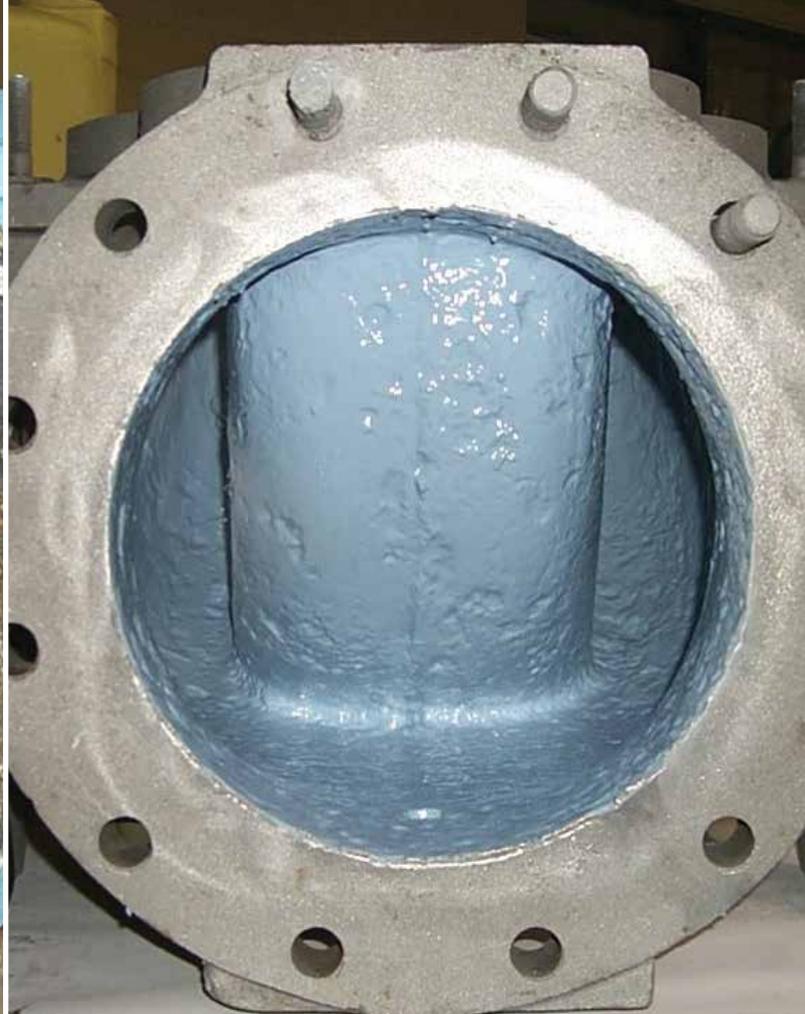
Photos show a 150-hp HSC pump installed in 1978 before (left) and after (right) sandblasting and coating. MCWA field tests have shown some encouraging results of the benefits of sandblasting and coating pumps as an essential step toward returning a pump to its original manufacturer's specifications.

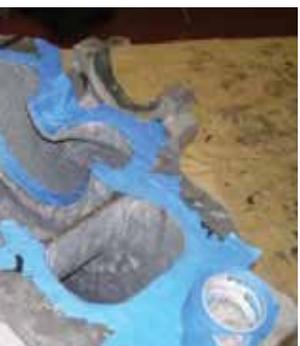
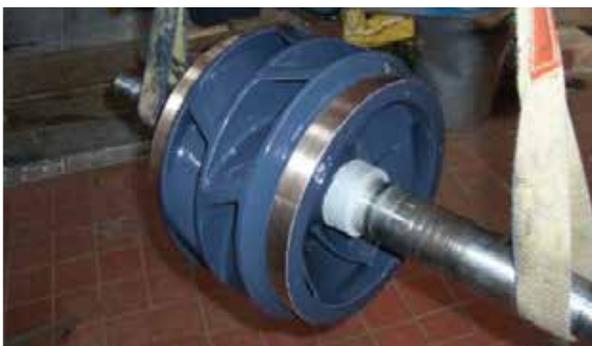
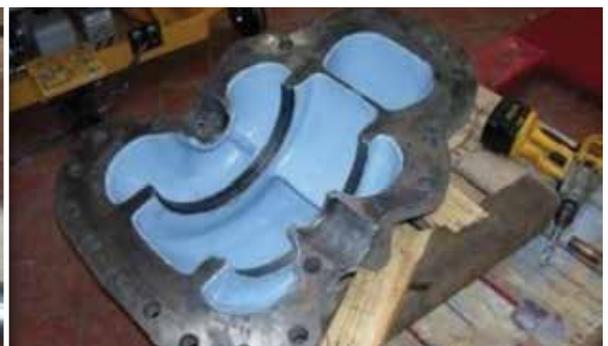
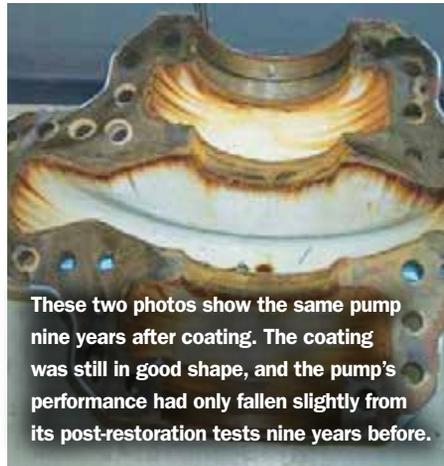
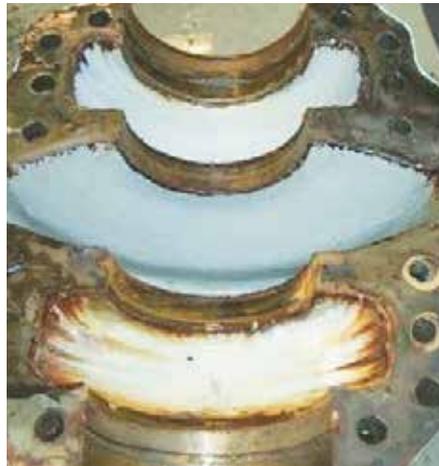
specifications (Figure 1), one of the project's early concerns was whether the coatings would last. Above are field inspection photos of the inside of a pump that was coated nine years ago and has been in service ever since.

Two coats of the ceramic epoxy coatings had been applied to the inside casings of each pump coated. Although it'd been a little like painting with honey, which made it somewhat difficult to apply and control the thickness of each layer, each coat was generally applied in layers 10–15-mm thick. There were some cracks in the coating that didn't show up in the photos, but overall the coating was still in good shape, and the

performance of the pump had only fallen slightly from its post-restoration tests nine years before.

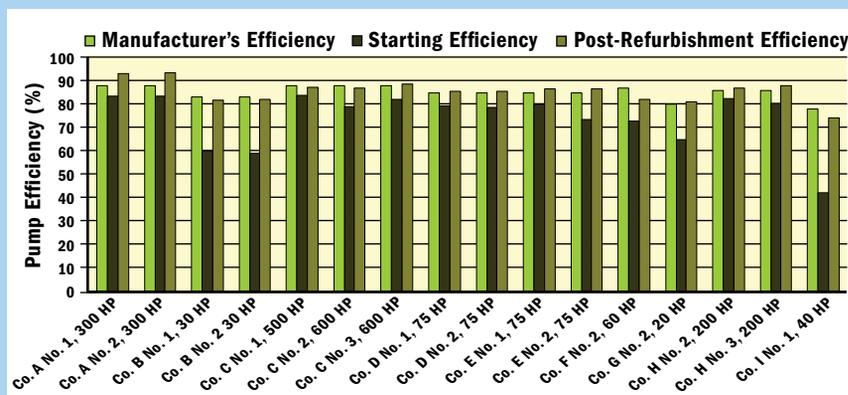
Figure 1. Pump Efficiency Improvement

MCWA's pump coating program can result in efficiency and performance improvements that may exceed the manufacturer's published pump curve.

Applying a ceramic epoxy coating to the inside of an HSC pump significantly improves and maintains the pump's performance and efficiency.

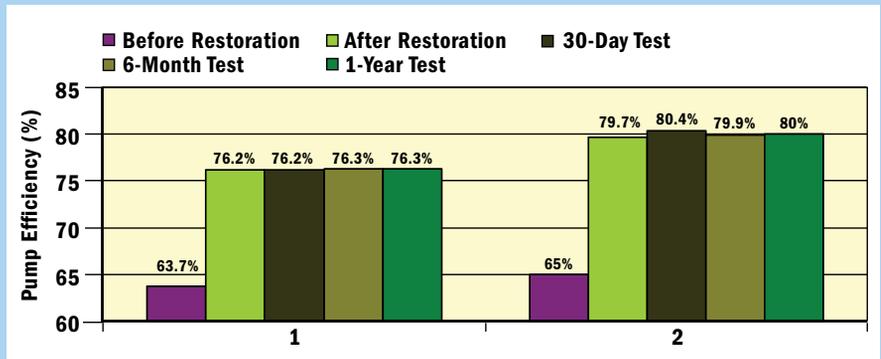
Figure 2. 20-hp Pump Efficiency (Initial and Over Time)

Figure 2 shows how initial pump efficiency of the two 20-hp pumps before restoration was about the same. However, the uncoated pump's efficiency after restoration consistently tested lower than the coated pump's. Although not shown in the figure, the uncoated pump's head and flow also have consistently tested lower than the coated pump's. Post-restoration testing of the coated pump hasn't shown a significant drop-off in efficiency. This would indicate a return of roughness in the uncoated pump that has resulted in lower efficiency from tuberculation buildup.

Using three sets of identical pumps for the comparison, the first pump in each set was only sandblasted. The second pump was sandblasted and coated.

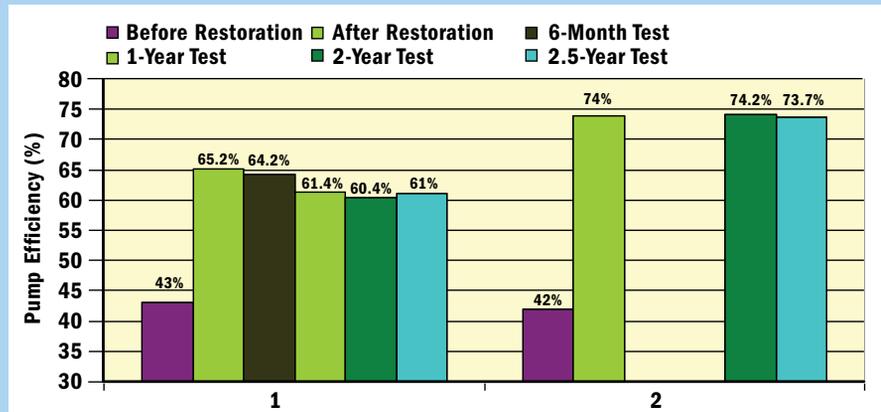
Figure 3. 40-hp Pump Efficiency (Initial and Over Time)

Figure 3 shows how initial pump efficiency of both 40-hp pumps more or less was the same. Post-restoration testing of both pumps indicates that efficiency of the coated pump was

8.8 percent higher than the sandblast-only pump. The uncoated pump's efficiency reduced 4.2 percent after two years of service, as shown in the post-restoration testing figure. The coated pump's efficiency declined less than 1 percent during the same time period. This suggests that corrosion and tuberculation buildup inside the uncoated pump is causing a decline in pump efficiency.

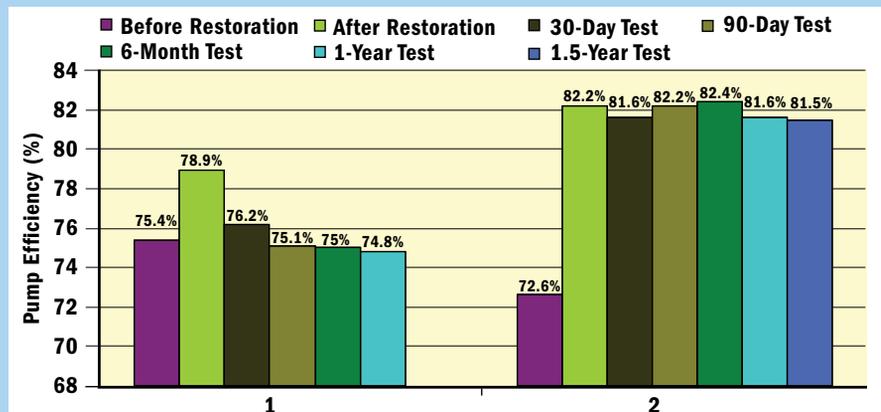
Figure 4. 60-hp Pump Efficiency (Initial and Over Time)

As shown in Figure 4, initial pump efficiency of the 60-hp pump to be sandblasted only was 2.8 percent higher than the initial pump efficiency of the pump scheduled for sandblasting and coating. However, after restoration, the coated pump's efficiency was 3.3 percent higher than the uncoated pump's (82.2 percent compared with 78.9 percent).

The uncoated pump's efficiency reduced 4.1 percent after two years of service, as shown in the post-restoration testing figure. The coated pump's efficiency declined less than 1 percent during the same time period. This suggests that corrosion and tuberculation buildup inside the uncoated pump is causing a decline in pump efficiency.
