## Challenge

## Solution

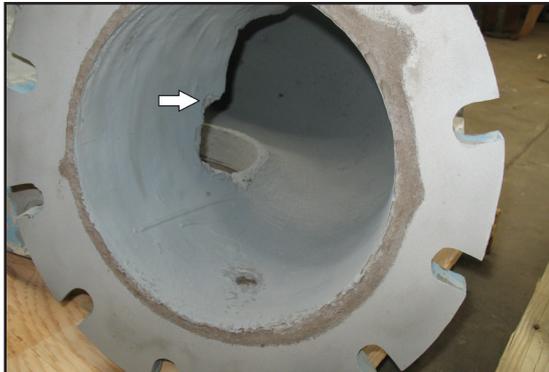
The pump was no longer producing the same amount of pressure that it had in years past and was taking longer to perform the same amount of work. The operators noticed a sound similar to cavitation while the pump was running.

Sandblasting, the significant extent of the wear on the pump cut-water revealed.

A wire-to-water efficiency assessment of the pump was conducted to determine actual pump efficiency and cost of operation. As a result, a decision was made to pull the pump out of service for a full refurbishment and application of internal coatings.

- **ARC 858** and **ARC 855** protective coatings were used to restore the internals of the pump to like-new geometry and clearances.
- The wetted surfaces were treated with a low coefficient of friction, high efficiency, ceramic-reinforced epoxy coating system to resist corrosion and erosion. Low coefficient of friction coatings reduce pipe friction losses leading to improved efficiency.

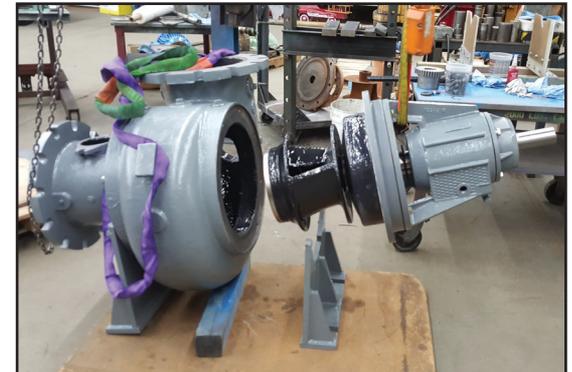
Application of the coating system not only protects the asset but also reduces surface energy for improved efficiency.
