Challenge

Holding bays containing gypsum byproduct from the FGD process were leaking water into personnel areas, creating a slipping hazard.

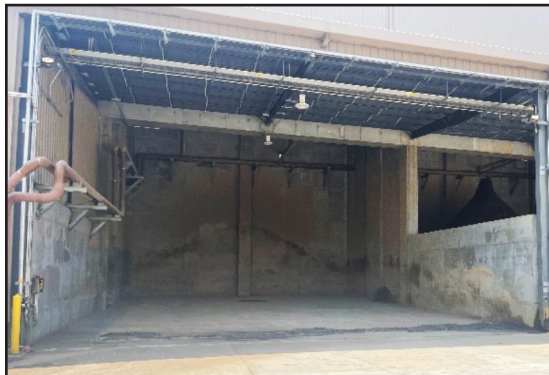
Repeated freeze/thaw cycles led to expansive cracking of the concrete walls and subsequent leakage between bays.

Bays with cracking on walls before repairs.

The cracks were “V” ground out and the surfaces were diamond ground to CSP 3 finish.

Chesterton® ARC 797 was applied to the walls and crack regions.

Fiberglass tape was applied over the cracks, pressing it into wet ARC 797.

Chesterton ARC CS2 was applied to the walls and sumps in two successive coats of 10 – 12 mils for a total DFT of 20 – 24 mils.

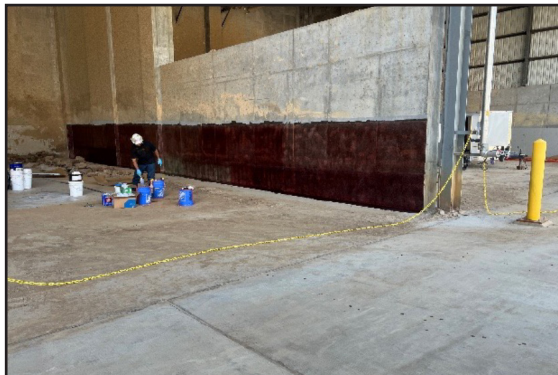
After diamond grinding, ARC 797 with fiberglass tape overlay was applied to the cracks.

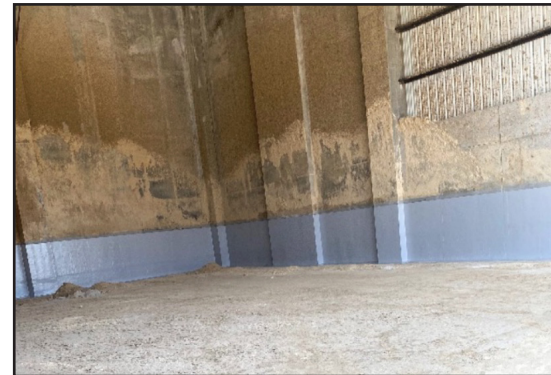
After ARC 797 and tape repairs were completed, all surfaces received two 10 – 12 mils coats of ARC CS2.
