Challenge

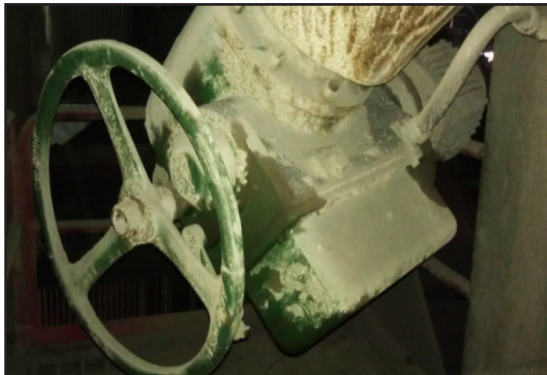
- Leakage from an invertedly installed valve let water get into the actuator and resulted in damage. Client was facing replacement cost of \$20K
- Steam blowing and/or water was dripping into the bottom of the MOV, causing repair costs of up to \$75K/day
- Client's current graphite packing caused stem pitting and created a leak path. The packing was rendered ineffective

Inverted valve.

- Reconfigured the stuffing box which had an eleven-ring set to five rings and a carbon bushing to fill the box
- Replaced failed packing with 5 rings of 1601, a reinforced graphite braided tape with a built-in passive corrosion inhibitor to minimize stem pitting
- Applied **Chesterton 725**, a high-performance nickel anti-seize, during installation on new packing studs for proper torque application

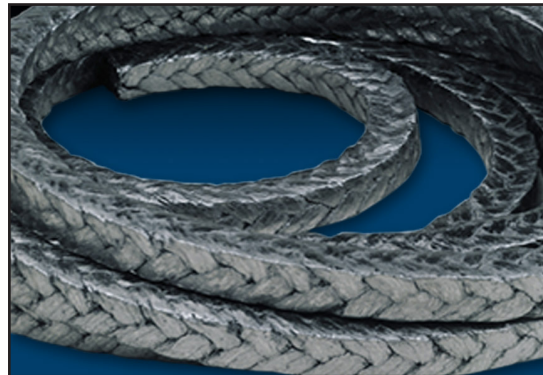
Chesterton 1601.

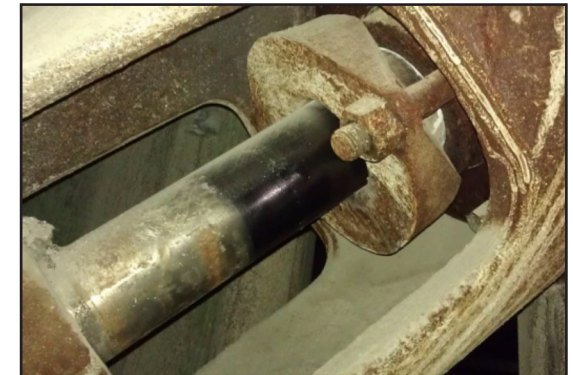
After six months of operation, the packing solution is still leak free with greatly reduced downtime. Due to valve's inverted orientation, the new corrosion-inhibiting products saved both the stem and the actuator.

Leak free.
