Challenge

The concrete above an aeration basin was spalling badly after the existing coating failed within 24 months. This led to concrete dropping into the clarifier which lead to underflow pump service interruptions.

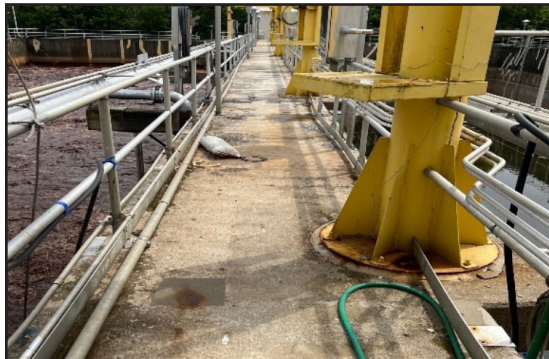
Moisture-saturated concrete was spalling due to freeze thaw cycles.

Existing coating was failing, causing the concrete to deteriorate.

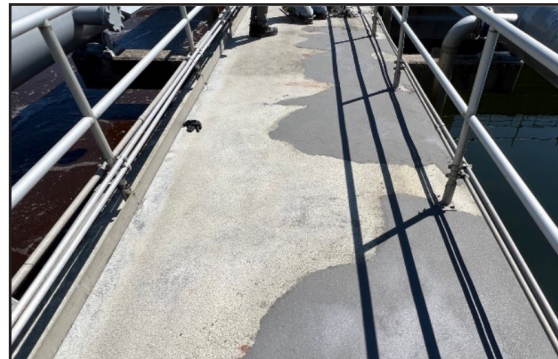
Loose and damaged concrete repaired with ARC EG-1.

All surfaces were water washed. Heavily damaged areas were prepared with chipping hammers. Wherever concrete spall repairs were required, key cut terminations were employed. Finally, all surfaces were diamond ground to CSP 3 finish.

Chesterton® ARC EG-1 was used to repair all spalled areas.

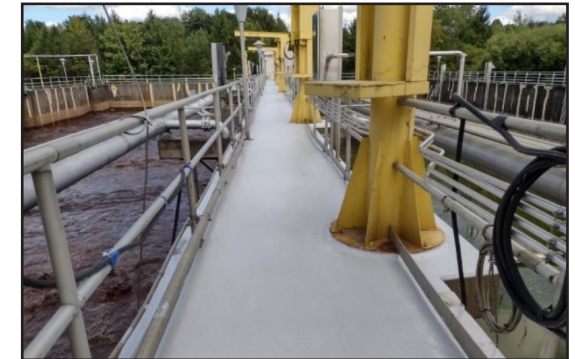
Concrete protected with two coats of ARC CS2 with a non-slip finish.

Chesterton ARC CS2 was applied at 15 mils and then broadcast to rejection with non-slip grit. After the initial cure, the excess grit was swept away and a 15-mil sealer coat was squeegee applied for a sealed, slip-resistant surface.

Two catwalks were protected in 4 days. Surfaces are now virtually free of spalls, loose concrete, and trip hazards and present a sealed, slip-resistant surface.
