Challenge

At a large shipyard's hull manufacturing plant, the rod and piston bronze bushings of a 2000T steel plate forming press cylinder were worn. This caused excessive radial movement and metal scoring of the moving metal components.

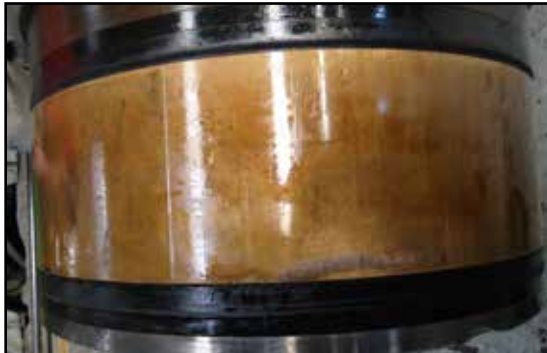
The existing bronze bushings of the pistons and rods were worn by excessive lateral load on the cylinders and by the high number of press cycles. The radial movement caused mechanical damage of the hydraulic seals on the pistons and rods, leading to malfunctioning of the press cylinders.

Worn, scored piston bushing.

The Chesterton engineering team recommended refurbishment of the worn bushings based on failure analysis of the seals and equipment inspection.
