Chesterton Wear Rings Reduce Product Loss on Extrusion Machine

A European cookie manufacturer needed to upgrade a cream extrusion machine used to make biscuits.

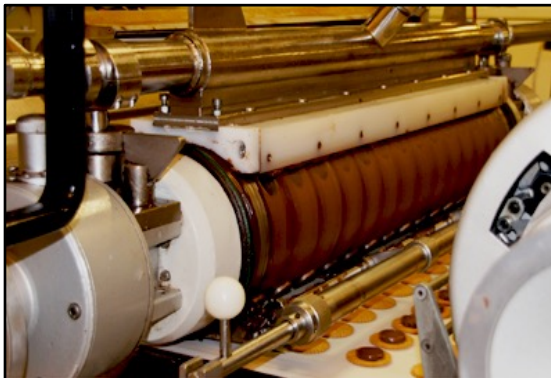
Cream extrusion roller equipment.

The current wear rings caused scoring of the internal cylinders roller, resulting in expensive repairs or replacement of the rollers. Each roller has 70 pistons.

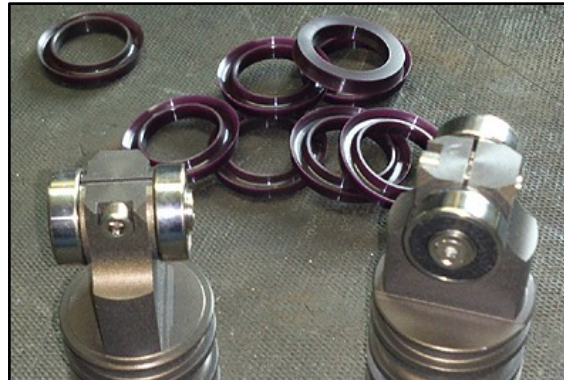
Pistons with P22KN Rod and Piston Seal with 19K Split Wear Rings.

- **P22KN Rod and Piston Seal** using the **AWC800 material**. The seal design offers a positive-rake lip profile for optimal radial sealing load with minimal frictional resistance.
- **19K Split Wear Rings** using **AWC600 material**. These bearings reduce radial movement to help extend seal life.

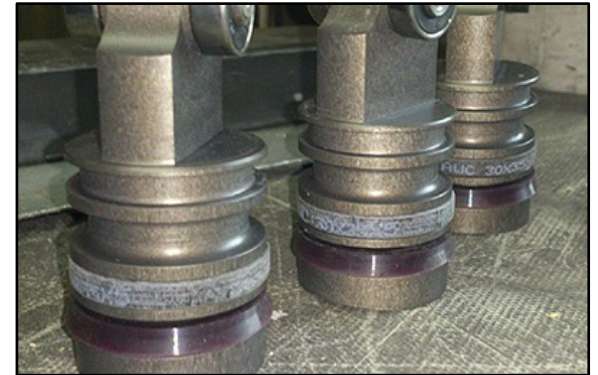
Chesterton P22KN with 19K extends the life of each piston.

The customer has been using this solution since 2010. The Mean Time Between Repair (MTBR) is 3X the previous solution.
