## Challenge

### Cost-Effective Belt Dressing

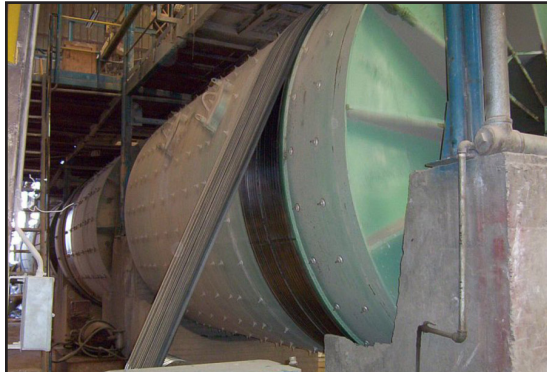
- A ball mill pulverizing ceramic powder was driven by a set of 18 belts which had stretched and were slipping
- The result was a loss of power and rpm. The slipping increased operating temperature of the belts, causing a significant reduction in belt life
- A new set of belts cost \$3,000 and required 24 hours to install – one full day of lost production

Rotary ball mill driven by 18 V-belts, which were slipping.

- Apply **Chesterton 730 Spragrip** where the belts entered the pulley
- Apply aerosol belt dressing from a safe distance using the pinpoint stream
- The belt flapping stopped immediately, indicating belt slippage was eliminated

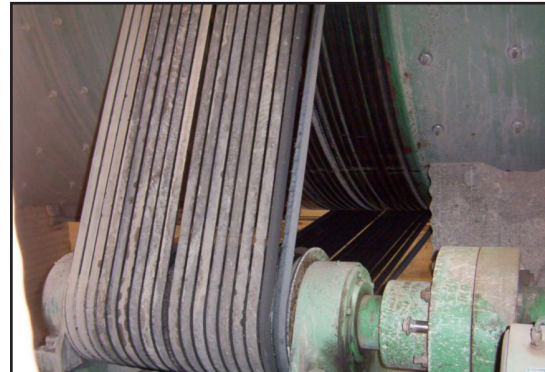
Apply Chesterton 730 Spragrip to eliminate belt slippage.

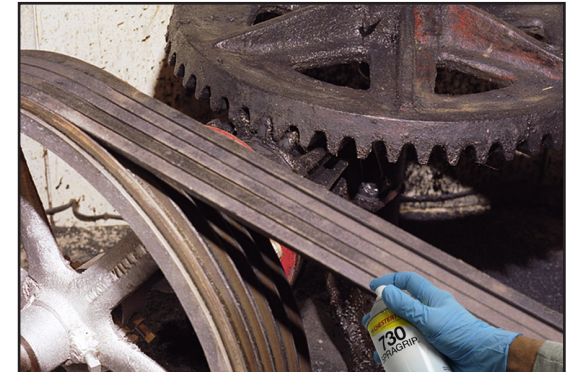
Spragrip extends belt life and reduces lost production.

- Increased belt life by 100% and improved process efficiency by 5%
- Customer avoided cost of new belt sets
- Production remained up and running
- The application of **Chesterton 730 Spragrip** took only 10 minutes
