# Split Seals Deliver Reliable Wastewater Pump Sealing for Three Years Running

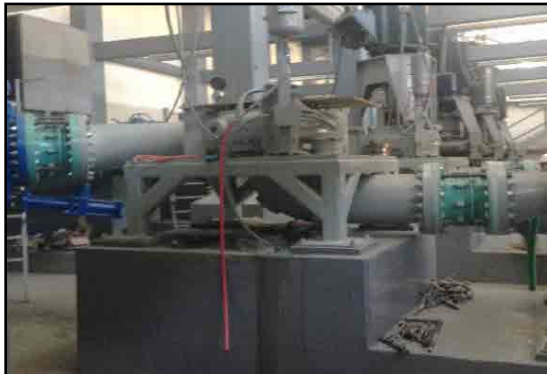
*Dirt around the pump shows failure of original OEM dual seal.*

The operator of a wastewater pumping station in Mexico acquired four new pumps to replace old equipment. Originally the pumps were supplied with OEM dual seals using Plan 53A. However, that setup failed during the on-site test due to poor installation and inefficient operation of the Plan 53A. The pump operator wanted to migrate to a solution intrinsically reliable, and free of monitoring and additional operating costs.

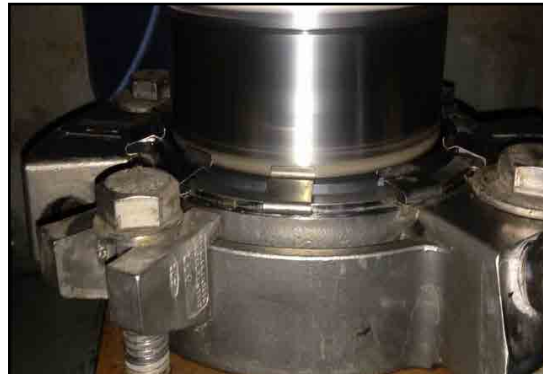
*Chesterton 442 Split Seal during pump operation.*

Chesterton analyzed the application and recommended the use of **Chesterton 442 Split Seals** with SSC/SSC faces and EP O-Rings. Used with **SpiralTrac™ Version D/Type A** throat bushing technology, the solution could use Plan 13 without any flush.

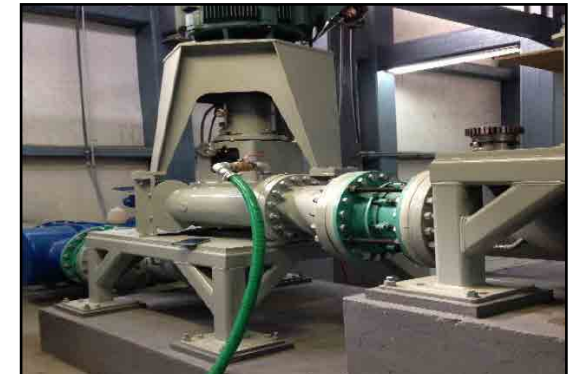
*Pump and leak-free area with 442 installed.*

The **Chesterton 442 Split Seal** solution was installed on October 2015. As of July 2018 the pumps have been running leak free.
