Challenge

Background

A1-year-old self-priming pump in an industrial storm water application failed catastrophically. High vibration and seal leakage was observed during the failure. Cavitation was suspected as the cause of the vibration. Evidence was found upon pump inspection as the cast iron impeller eye was damaged.

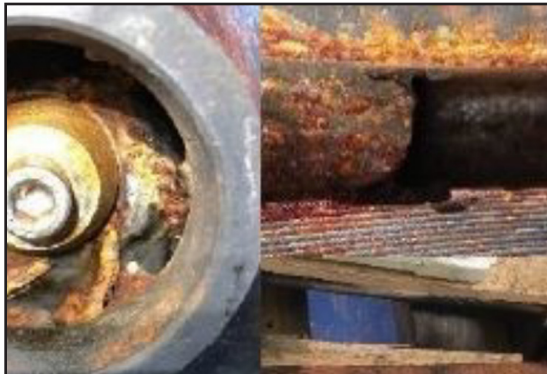
Damaged pump.

The pump was completely overhauled with **Chesterton® ARC 5 and ARC SD4i** coatings on the existing casing, CD4 impeller, **30K Advanced Lip Seals**, and **630 SCXF High Performance Grease** for exceptional bearing protection.

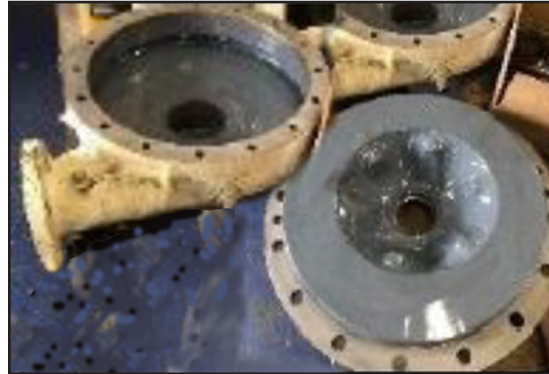
Chesterton product group: Chesterton Connect Sensor, ARC 5 and ARC SD4i coatings, 30K seal and 630 SCXF grease.

The pump was then reinstalled along with a **Chesterton Connect™ Sensor** to monitor vibration and suction pressure to avoid cavitation. A minimum liquid level in the cellar was discovered and raised.

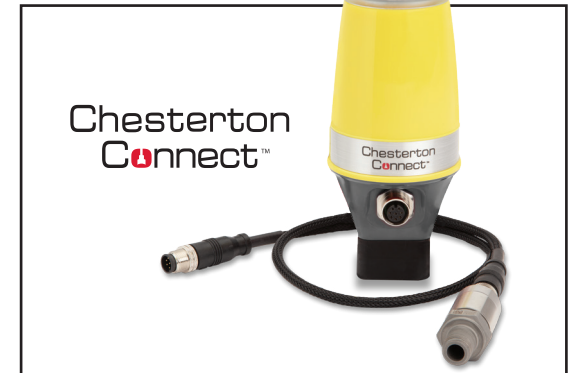
Chesterton Connect Sensor.

The **Chesterton Connect Sensor** helped the customer identify issues, make changes, and monitor pump and system health along the way. In the two-year period following installation, the pump continued to run smoothly with minimal seal and vibration issues.
