Challenge

Background

Chesterton 1730 Synthetic Packing and Chesterton 5150 Rotary Live Loading

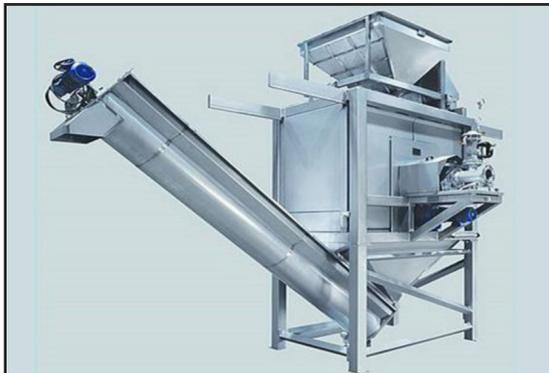
Steam peelers remove the skin from fruits and vegetables by exposing them to high pressure and high temperature steam.

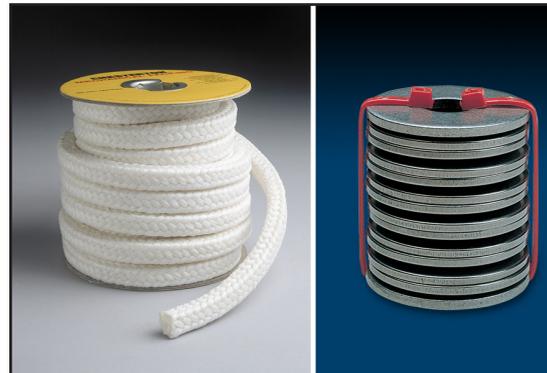
Chesterton 1730 and 5150 Rotary Live Loading.

A 3-ring **Chesterton 1730™** packing set was selected as it is very resistant to abrasion but will not damage the shaft.

The spring-loaded **Chesterton 5150 Rotary Live Loading** system helps prevent particles from entering the stuffing box and maintains a constant sealing force.

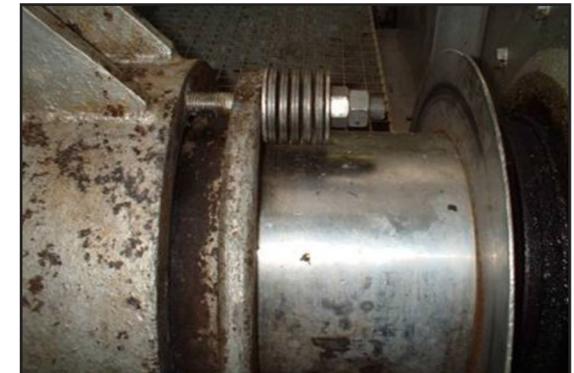
Chesterton's 5150 Rotary Live Loading system avoids leakage by automatically maintaining the correct sealing force on the packing set.
