## Challenge

### Background

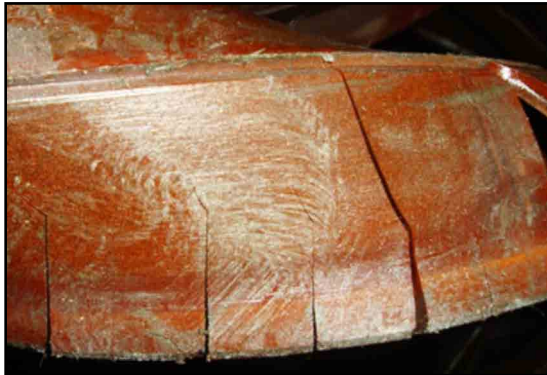
The existing bearing protection seals had a very short lifetime (2-3 months) due to chemical compatibility issues between the seal material and rolling emulsion. The rolling emulsion attacked the seal material, causing softening and cracking of the seals.

Lip of the failed seal

The Chesterton engineering team developed a retrofit custom sealing solution based on failure analysis of the existing seals and application inspection. The seals were tested by the customer, inspected after three months of operation.

The **50KWS Mill Rotary Face Seal** has an integrated finger spring and clamping band in combination with a high-performance FKM compound. The seal is designed to provide long-lasting sealing and superior protection against ingress of solid particles and emulsion.

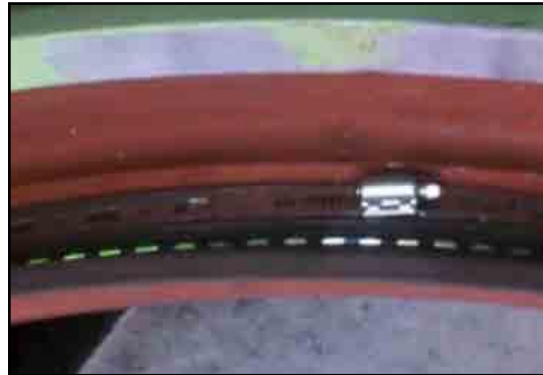
Chesterton 50KWS with clamping band

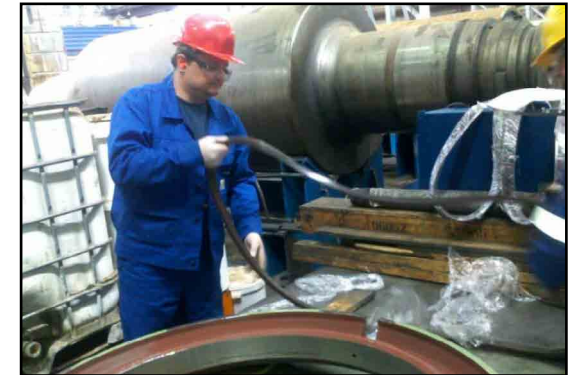
Installation of 50KWS seal
