Matrix Split Seal Saves Oil and Stops Leakage in Steel Mill Gearboxes

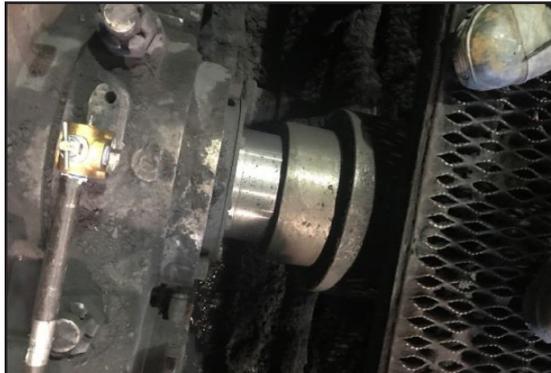
- A steel mill had significantly worn out shafts with the gearboxes on the “repeater” of the wire mill. The wear was caused by running various rubber-style lip seals.
- Gearboxes were leaking oil consistently upon startup after a new competitor seal was installed. This progressively worsened causing significant oil/grease loss and major housekeeping issues.

Rubber lip Seals were causing shaft wear.

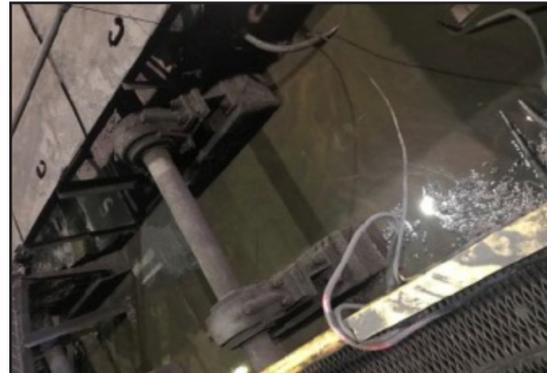
Chesterton Matrix Rotary Seal will adjust to the shaft axis to avoid wear.

Replaced competitor’s seal with the **Chesterton Matrix Rotary Seal**, a split polymer seal that can be installed in minutes minimized critical downtime.

- A unitized design.
- Advanced polymer combined with impregnated synthetic fiber packing technology to maximize performance.
- Positively seals out bearing contamination while keeping lubrication in.
- Withstands large runout conditions and vibration.

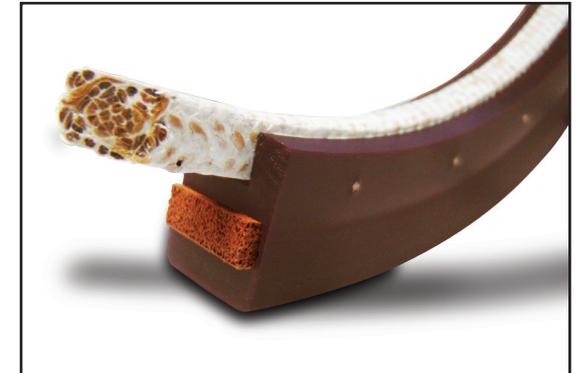
- The **Chesterton Matrix Rotary Seals** running leak-free since installation (over six months).
- Piping improvements and the **Matrix Seals** have resulted in a drastic oil consumption reduction from nine truck tankers to three each year.
- An ROI study revealed **\$177,500 in net oil savings in six months.**

Leak-free performance saved over \$177K in oil in six months.
