Challenge

A large steel cold rolling mill experienced premature seal failure and intensive leakage of the back-up roll chocks of a reversible cold rolling stand. The leakage required unscheduled downtime to replace seals and raised environmental concerns due to leakage.

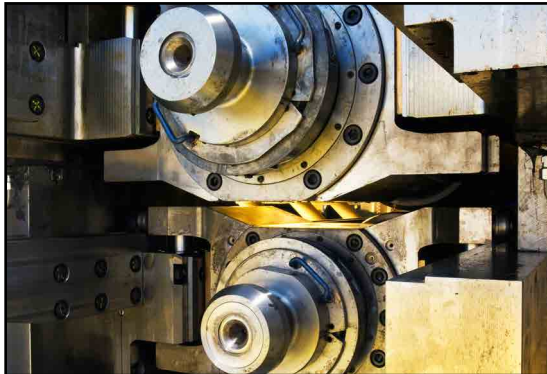
The original manufacturer's rotary seals had a short lifetime because of high peripheral speed, leading to the hardening and cracking of the seal lips. This condition resulted in high maintenance costs, lost bearing lubrication oil, and reduced production.

Work and back-up roll of rolling stand

Chesterton's local specialist recommended an advanced, heavy-duty rotary seal solution.

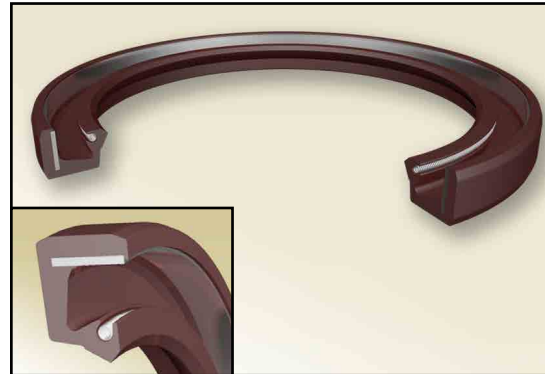
The unique design includes a flexible stiffener ring that ensures improved fitting in the seal cavity and allows for installation in stuffing boxes without end covers. A helical garter spring maintains the seal lip contact and sealing force on the shaft. A direct retrofit, this seal solution eliminates equipment modification.

Chesterton 52K Mill Rotary Seal

Chesterton seals far exceeded the customer's expectation during the evaluation period. The sealing solution was specified as the standard offering for all future rebuilds of the rolling chocks.

- MTBR increased by 2x
- Reduced lubrication oil leakage/loss
- Direct retrofit, which eliminates the need for equipment modification
