Challenge

Background

A shipping company had LNG (Liquefied Natural Gas) tankers, which take several days to fill. The gas is liquefied by lowering its temperature to -163°C . For every loading and unloading, operation pipelines are connected to the ship and these must be sealed with a gasket.

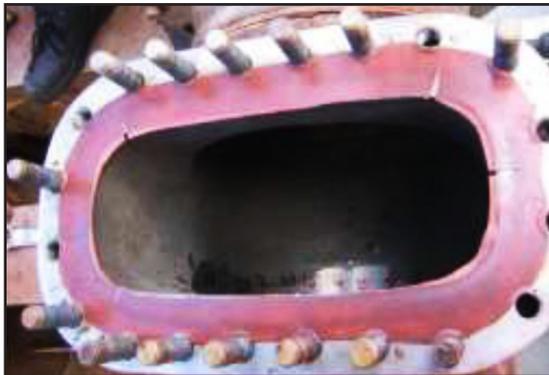
The customer was experiencing cracking of the gasket on the body of a spray line valve and in other applications, resulting in unsafe leaks and unscheduled shutdowns.

Cracked gasket.

Chesterton ECS-T Gaskets: a structured-filled PTFE gasket sheet that overcomes the issues that commonly arise when using PTFE gaskets.

- Offers a minimum service temperature of -200°C and is a good solution for use under cryogenic conditions
- Provide excellent performance in chemical applications where graphite is not resistant

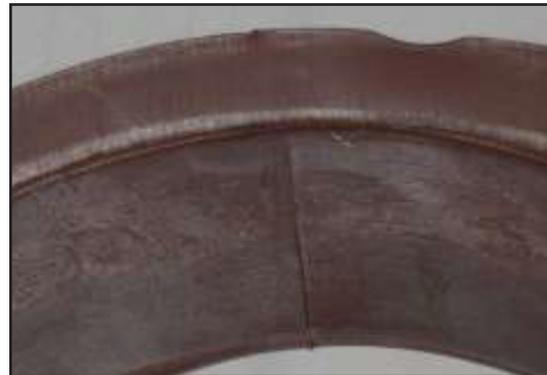
Failed gasket.

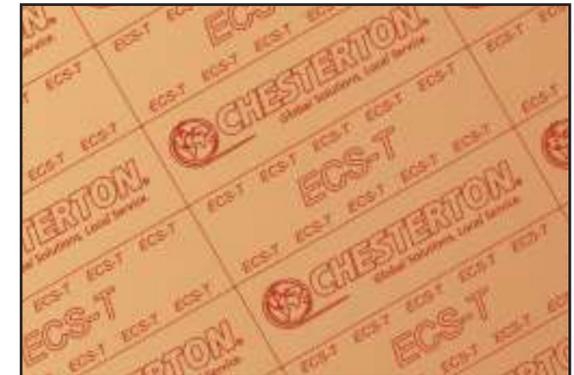
Chesterton ECS-T Gaskets are mechanically stable unlike common PTFE gaskets.
