Challenge

A potato chip manufacturer had significant leakage issues with 11 shell and tube heat exchangers. The exchangers had a Mean Time Before Repair (MTBR) of only six months. This type of heat exchanger often has sealing issues due to extreme temperature fluctuations which cause flanges and bolts to expand unevenly and can lead to stress in the equipment structure. Loss of gasket stress is common. The operating temperature was up to 280°C (536°F); 54 bar g (783 psig). The dimensions were up to 880 mm.

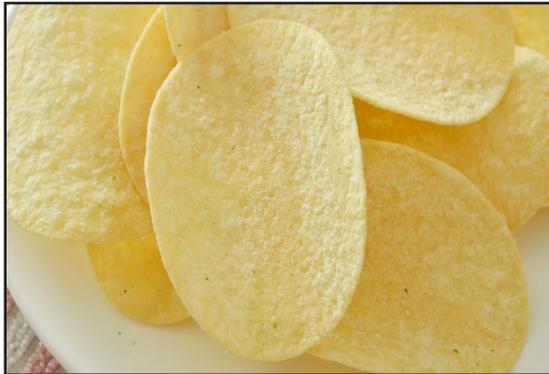
Heat exchanger leaks caused production downtime between stops at this potato chip factory.

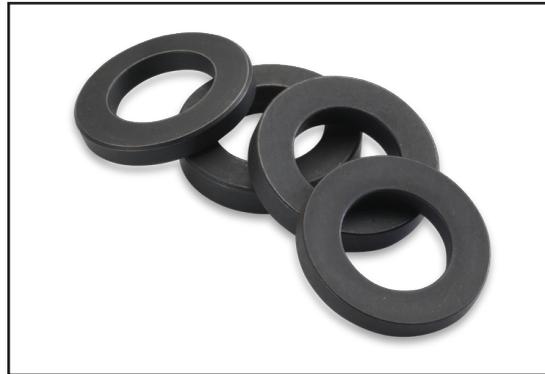
Chesterton 5505H Flange Discs offer shutdown-to-shutdown reliability.

Heat exchangers were upgraded to **Chesterton Flange Live Loading System**, which is designed for difficult sealing conditions. **Chesterton's 5505H High-Strength Disc Springs** give more travel to the bolts to prevent leakage.

The disc springs kept flanges leak-free by maintaining consistent tension on the bolts.
