Challenge

A water treatment plant had concrete floors damaged due to chemical spills which were unsafe for workers. Size: 130 m² (1400 ft²)

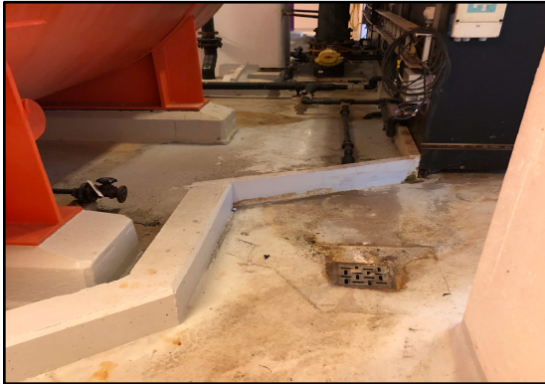
A caustic solution of Sodium Hydroxide (46%) and Hydrochloric Acid (30%) occasionally spills onto the floor, damaging the concrete.

Before: damaged concrete.

- Decontaminate surfaces.
- Mechanically roughen to CSP3 finish.

ARC NVE VC was applied by roller and applied at an average thickness of 30 mils. This two-layer coating system protects against a wide range of concentrated acids, organic solvents, and alkalis.

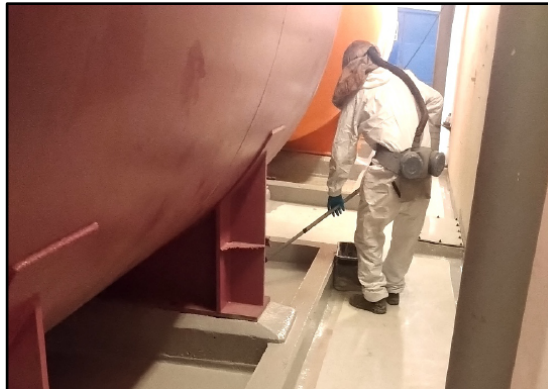
In progress: ARC NVE VC being applied.

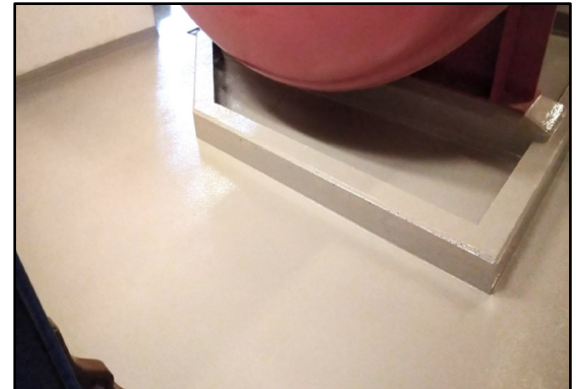
Client was extremely satisfied with the chemical resistance provided by ARC NVE VC and decided to coat other areas in the plant that were also exposed to chemical attack.

After: floor coated with ARC NVE VC.
