Gearbox Reliability Increases Savings by \$48K Over Eight Years

Food and Beverage Industry — Sugar Mill
Products: Chesterton 723 Sprasolvo™, 651 Detergent Lubricating Oil, and 615 HTG #1
Case Study 056 IL/MRO

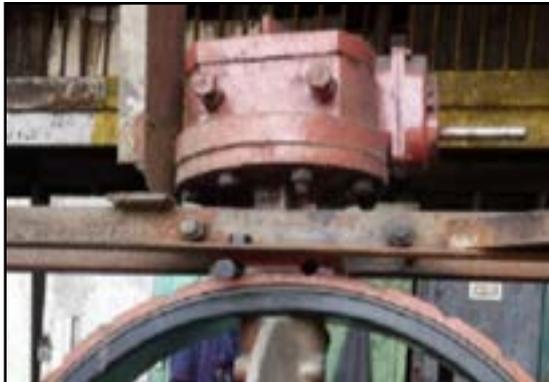
The cold water discharge valve at a sugar mill failed due to lack of lubrication in the gearbox. Hardened grease seized the gears, resulting in significant downtime and labor costs. Conventional lithium grease oxidized and hardened. The valve could not be actuated since the drive motors "tripped out" due to overload caused by gearbox seizure.

Seized butterfly volute due to gearbox failure.

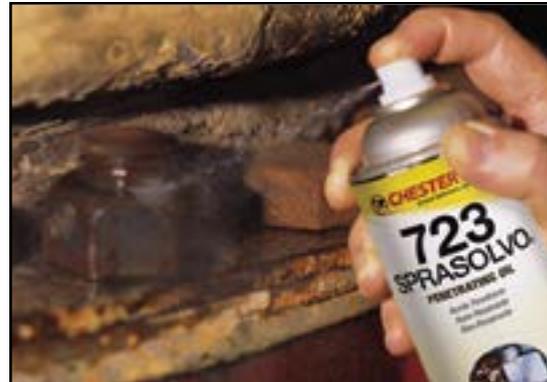
Chesterton 723 Sprasolvo™ softened old grease to free up the gear.

Chesterton 723 Sprasolvo™ was applied into the gearbox. This fast-acting, penetrating oil has an excellent capillary action that quickly loosens seized, rusted parts.

The old grease was removed by scraping and a final cleaning with **Chesterton 651 Detergent Lubricating Oil**.

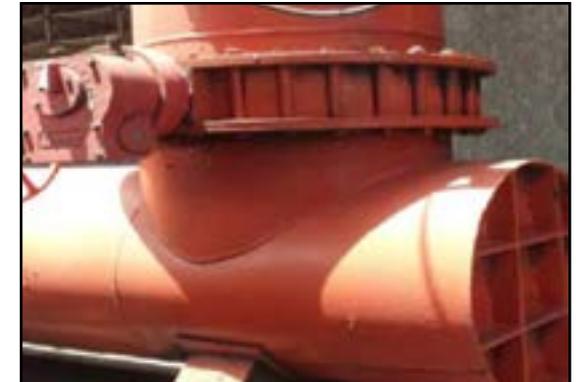
Chesterton 615 HTG#1 is now used for manual and motor drive gearboxes.

To prevent future seizures **Chesterton 615 HTG#1** was applied to provide adequate lubrication to the gearbox.

615 HTG #1 did not thin out, separate, or form hardened deposits.

Actuator gearbox has remained trouble free for eight years.
